Re: Riverbank Sampling — Operable Unit 1
Swan Island Upland Facility
Portland, Oregon
ECSI No. 271
1115-06

Riverbank Sampling Letter Report
Swan Island Upland Facility Operable Unit 1
Portland, Oregon

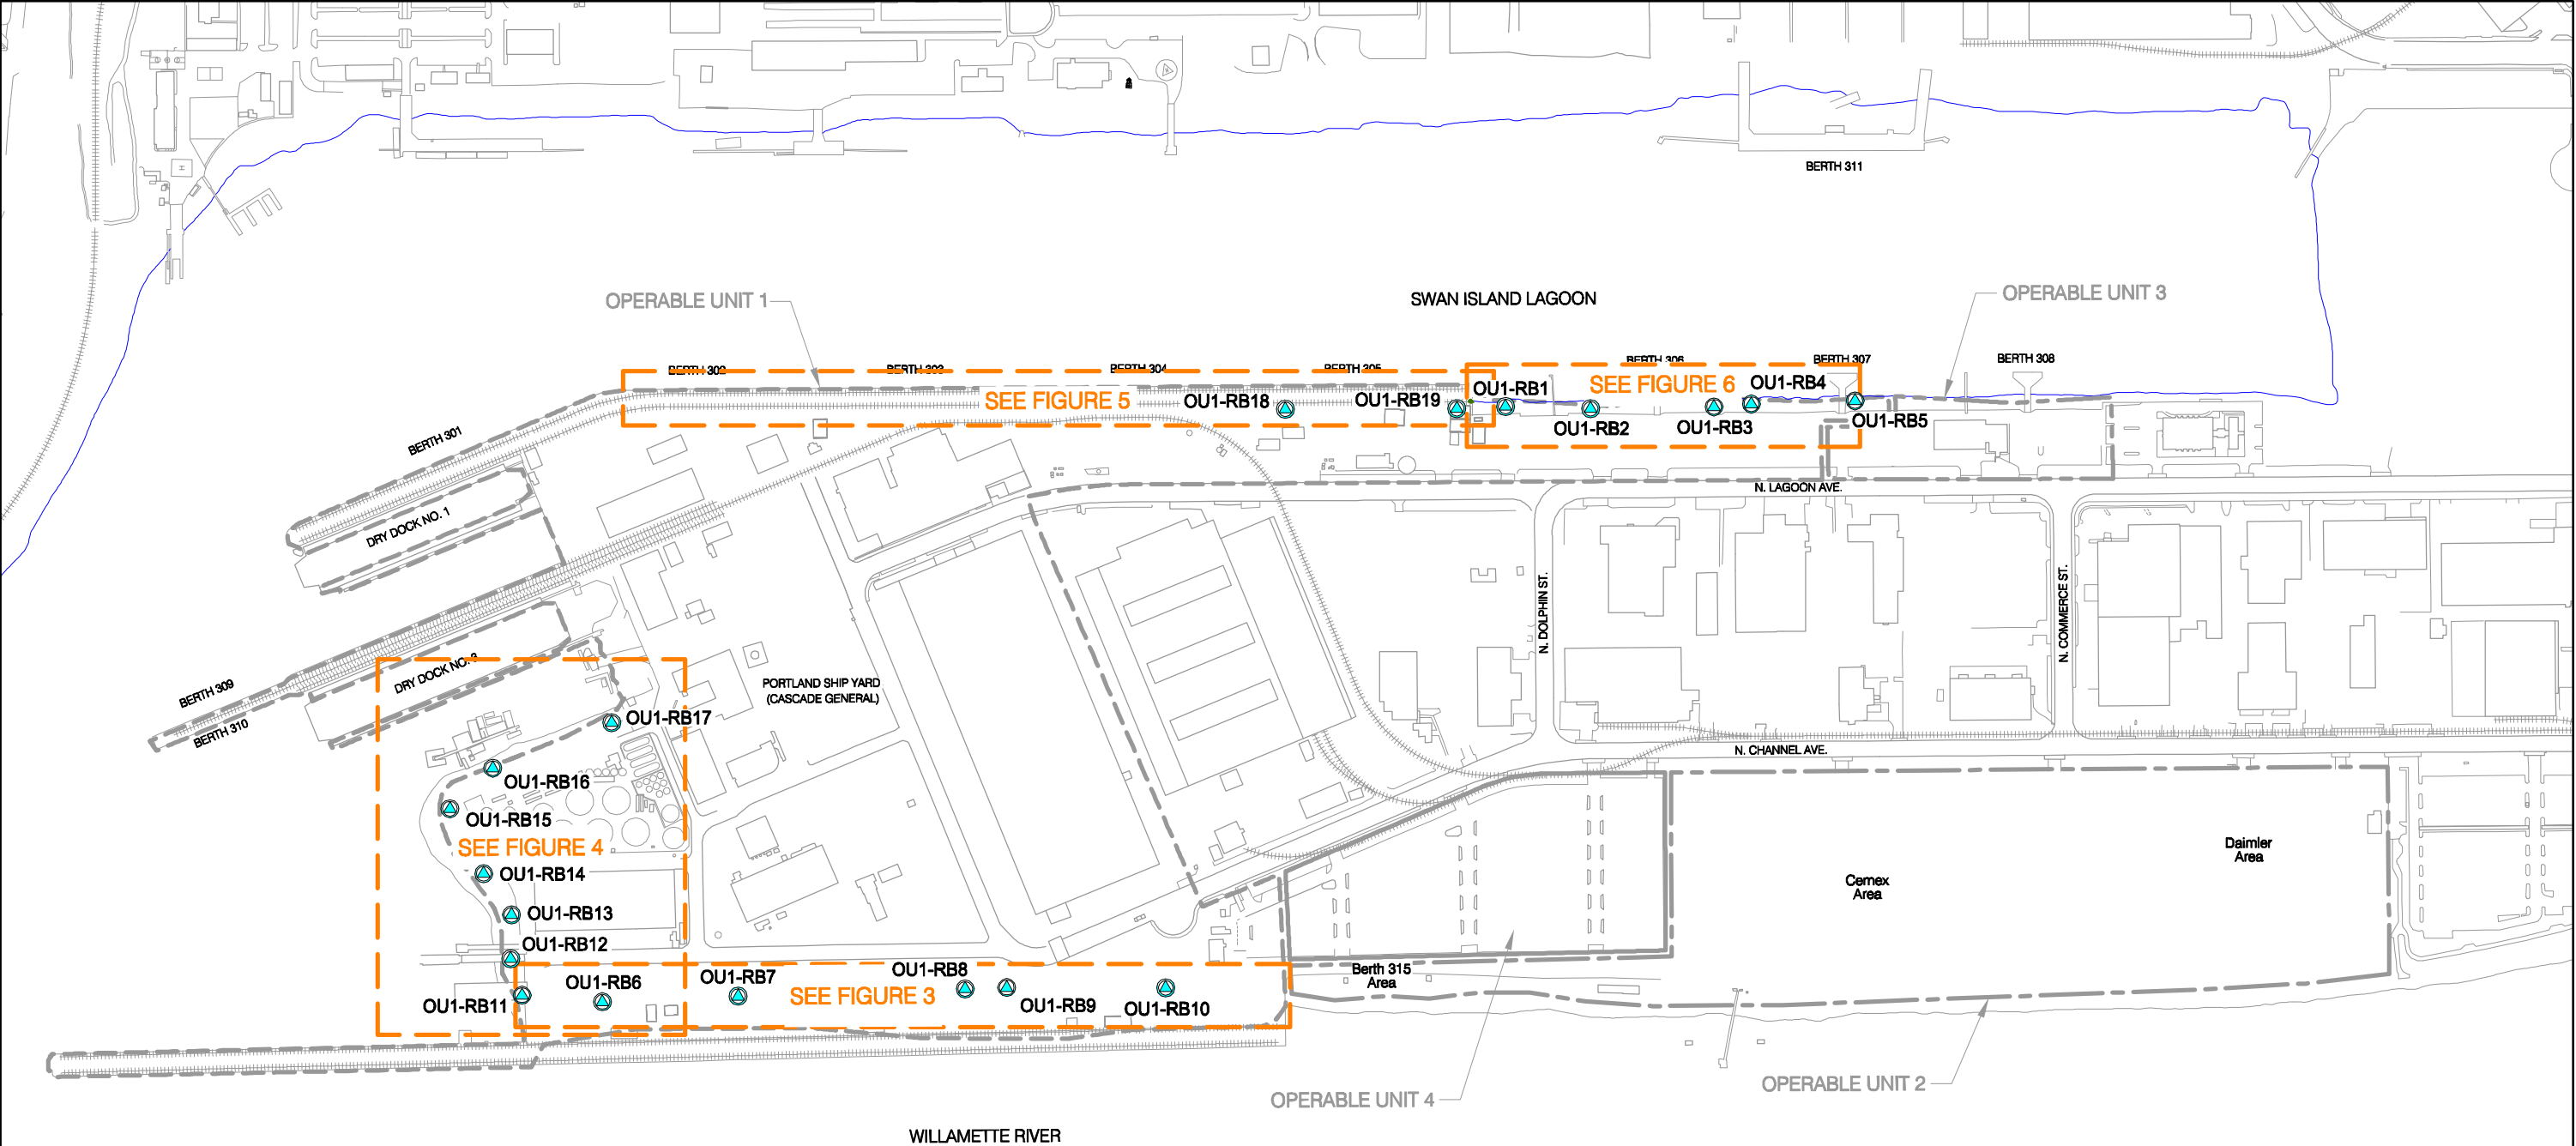
Ash Creek Associates A Division of Apex Companies, LLC	Project Number	1115-06	Figure 2
	November 2012

Figure 2 shows the 19 soil sampling locations (OU1-RB1 through OU1-RB19; established based on observations of potentially erodible soil above the OLHW). The samples were collected in accordance with Standard Operating Procedure (SOP) 2.2 (Attachment B). The samples were field screened for volatile organic compounds (VOCs) using a photoionization detector (PID) and for the presence of petroleum hydrocarbons using a sheen test in accordance with SOP 2.1 (Attachment B). No field indications of VOCs or petroleum hydrocarbons were observed.

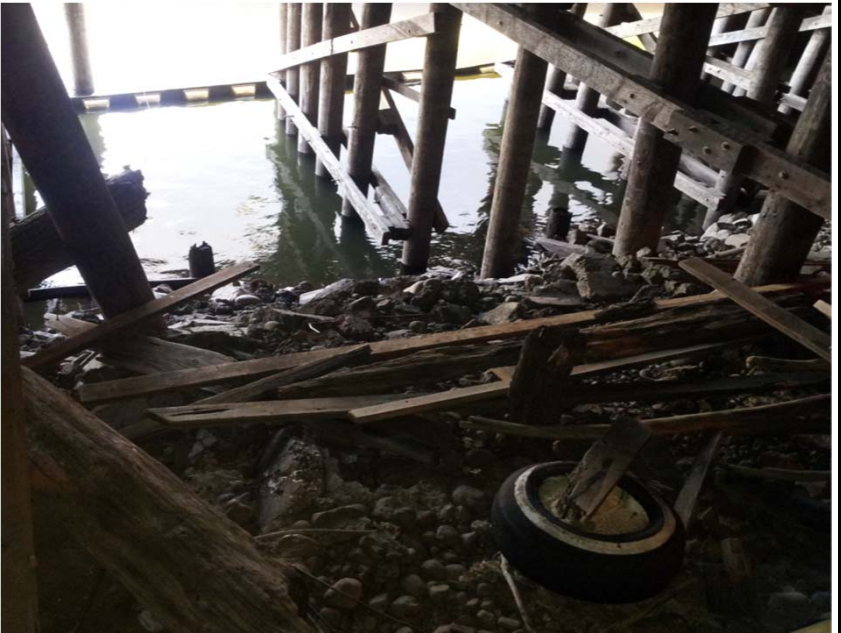
Photo No: 18

Photo Date: 8/24/2012	
Orientation: Northeast	
Description: Typical view toward river.
